EVALUATION OF OPTIMAL BATH GRAB BAR PLACEMENT FOR SENIORS

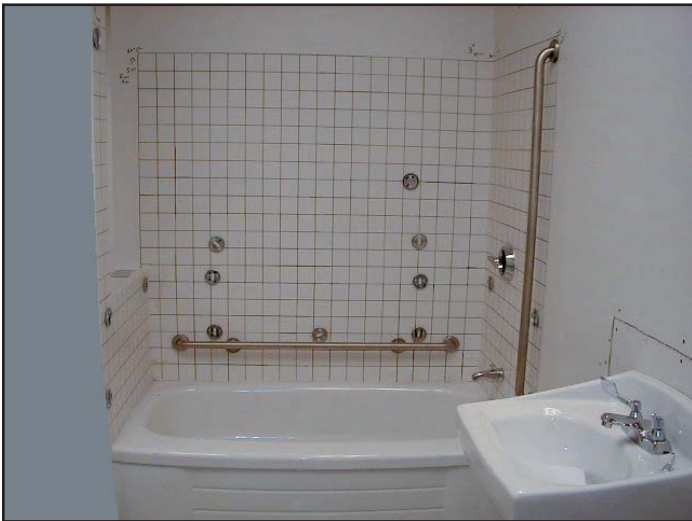
Figure 1 : Canadian Standards Association (CSA) configuration

The CSA configuration is one horizontal grab bar, 120 cm long, and one vertical grab bar, 120 cm long. Both grab bars are 18 cm above the rim of the tub. The horizontal bar is on the back wall of the tub. The vertical grab bar is on the same wall as the tub faucet.

The last two configurations ranked significantly lower than the others. The OBC was the only configuration that lacked a second bar on the entry wall. Also, the L-shaped bar was relatively ineffective in helping participants get in and out of the tub. The reasons for the low ranking of the CSA configuration are not fully understood as yet but may have to do with the excessively low positioning of the back wall bar.

2. For sitting down: there were no significant differences for the five configurations, although the CSA configuration was most used (87.3 per cent). Given the All Bars option, most participants used the angled or horizontal bar on the back wall for assistance (43.1 and 31.4 per cent, respectively).

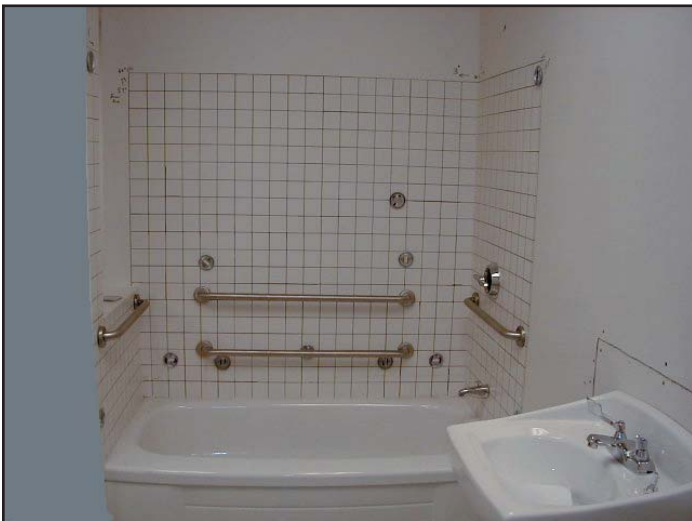
Figure 2 : U.S. Uniform Accessibility Standards (UFAS) configuration

The UFAS configuration is four horizontal grab bars. Two are mounted on the back wall; the third is mounted on the faucet wall; the fourth, on the wall opposite the faucet wall. Each back wall grab bar is 82 cm long.

The lower back wall grab bar is 23 cm above the rim of the tub. The upper is 48 cm above the rim of the tub. The bars on the faucet wall and the wall opposite the faucet wall are each 61 cm long and mounted 48 cm above the rim of the tub.

3. For standing up: there were no significant differences for the five configurations, although the UFAS was most used (86.3 per cent). Given the All Bars option, most participants used the angled or horizontal bar on the back wall (54.9 and 21.6 per cent, respectively).

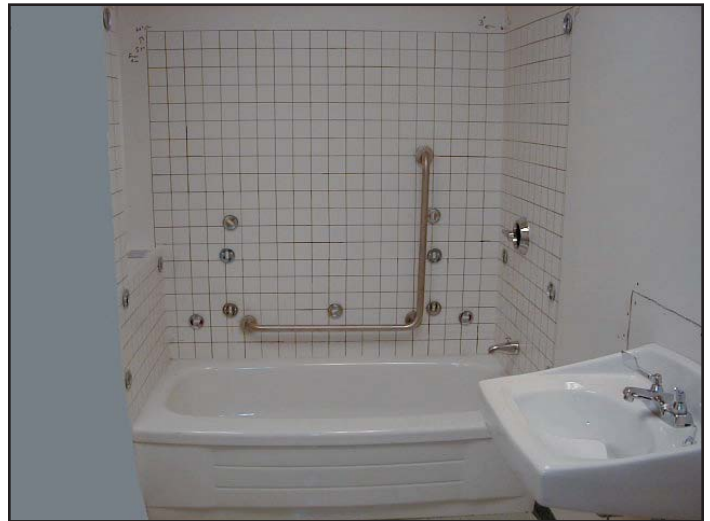
Figure 3 : Ontario Building Code (OBC) modified configuration

The OBC modified configuration is an “L”-shaped bar mounted on the back wall. Each side of the “L” is 75 cm long. The leg parallel to the rim of the tub is 17 cm above the rim. The vertical bar, at a 90-degree angle to the bottom of the “L,” is 38 cm from the faucet wall.

1. For getting into the bathtub: most used the OCC configuration (68.8 per cent); the OBC was used least (45.1 per cent). When given the option of All Bars, people used the vertical bar on the faucet wall most, followed by the angled bar on the back wall (32.3 and 20.6 per cent, respectively).

4. Getting out of the bathtub: the OCC was the configuration most used (62.7 per cent). The OBC was least-used (30.4 per cent). Given the All Bars option, most participants used the vertical bar on the faucet wall or the angled bar on the back wall (32.3 and 16.7 per cent, respectively).

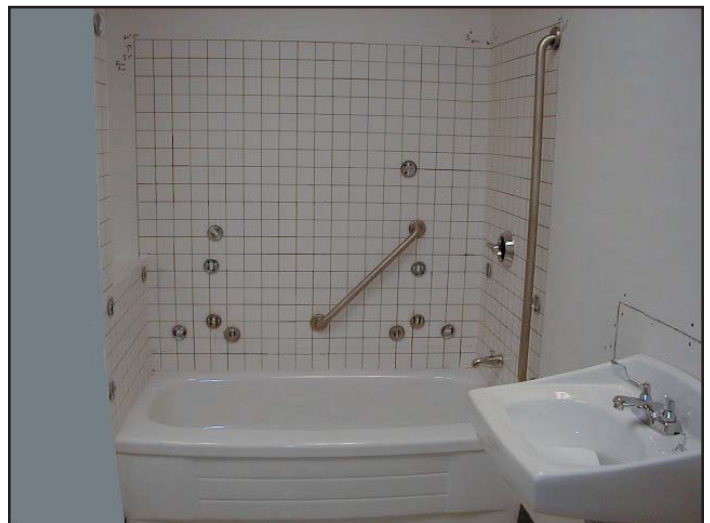
Figure 4 : Ottawa-Carleton Common (OCC) configuration

The OCC configuration is two bars. The bar on the back wall is 60 cm long. It is mounted at a 45-degree angle, with the lowest point 23 cm above the rim of the tub, 74 cm from the faucet wall. The highest point of the bar is 30 cm from the faucet wall. The second grab bar is on the faucet wall. It is vertical, 120 cm long, and 18 cm above the rim of the bathtub.

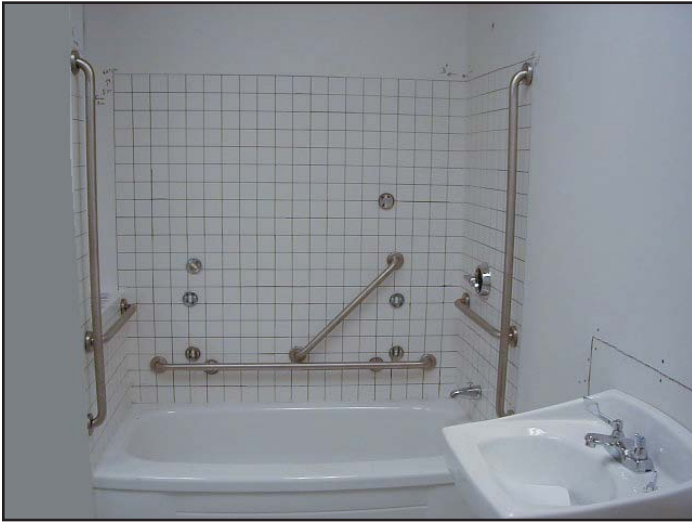
Figure 5 :All Bars configuration

The All Bars configuration is a composite of the CSA, UFAS, OBC modified and OCC configurations.

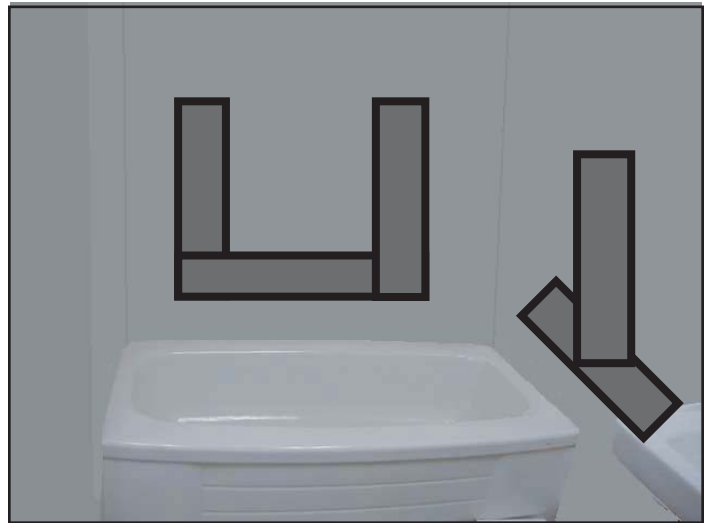
Figure 6 :The dark blocks indicate the “U-shaped” and “Inverted T-shaped” wall areas requiring reinforcement for grab bar installation

4. Non-slip surfaces on edges (bathtub rims, front and back) should be incorporated as safety features in bathtubs used by seniors.
5. In new bathtub constructions, a “U-shaped” drywall reinforcement in the back wall, along with an “L- or inverted T-shaped” drywall reinforcement area in each the faucet and head wall, should be incorporated to facilitate the installation of secure and appropriate grab bars.
